Product Safety Recall Bulletin

Bulletin No: 2006-6-01

Subject: Brake Disc and Brake Lever Assembly

2006 Prowler XT Models within the Vehicle Identification Range (VIN) of 4UF06MPV06T300001 - 4UF06MPV86T300781

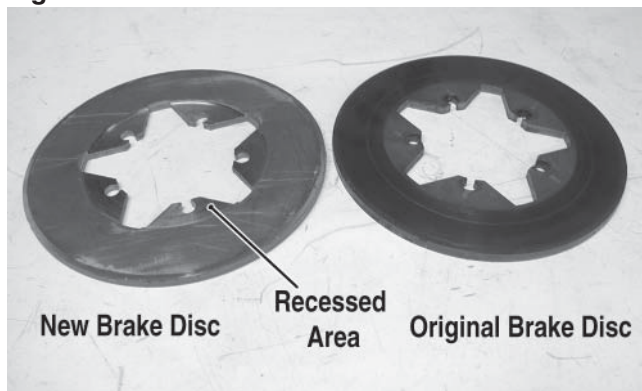
Fig. 1

Condition #1 - Brake Disc

The new brake disc will have a recessed (machined) area on the side facing the rear gear case. The new brake disc will also be secured with yellow shoulder screws contrasted to the original disc which is secured with black shoulder screws. See Fig. 1.

Condition #1: Brake Disc- In some instances, the rear disc may allow one of the brake pads to become misaligned, or in some cases, may be ejected from the floating caliper assembly. If this condition were to occur, it may lead to immediate or premature brake failure.

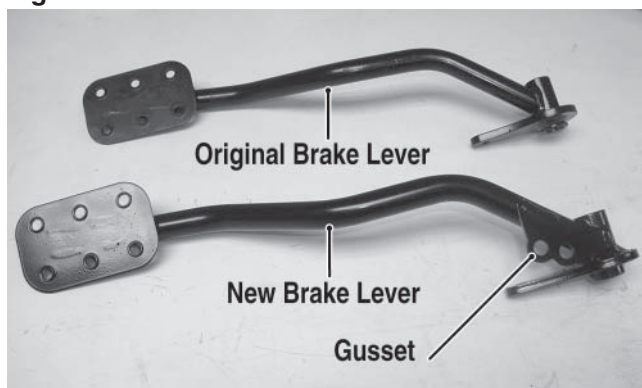
Fig. 2

Condition #2 - Brake Lever Assembly

The new brake lever will have a gusset welded to the backside of the upper section of the brake lever (next to the upper pivot tube). See Fig. 2.

Condition #2: Brake Lever Assembly- In some instances, the brake lever assembly may bend when subjected to a possible emergency load. If this condition were to occur, the bent brake lever assembly may limit the amount of brake lever movement limiting the braking ability.
