## Models Affected/ Items of Concern

Prior to releasing 2005 ZR 900 or Firecat 500/700 models, please service the following items. See Service Bulletin 2005-1-06 for VIN Range and related information.

### 2005 ZR 900 and Firecat 500/700 Models

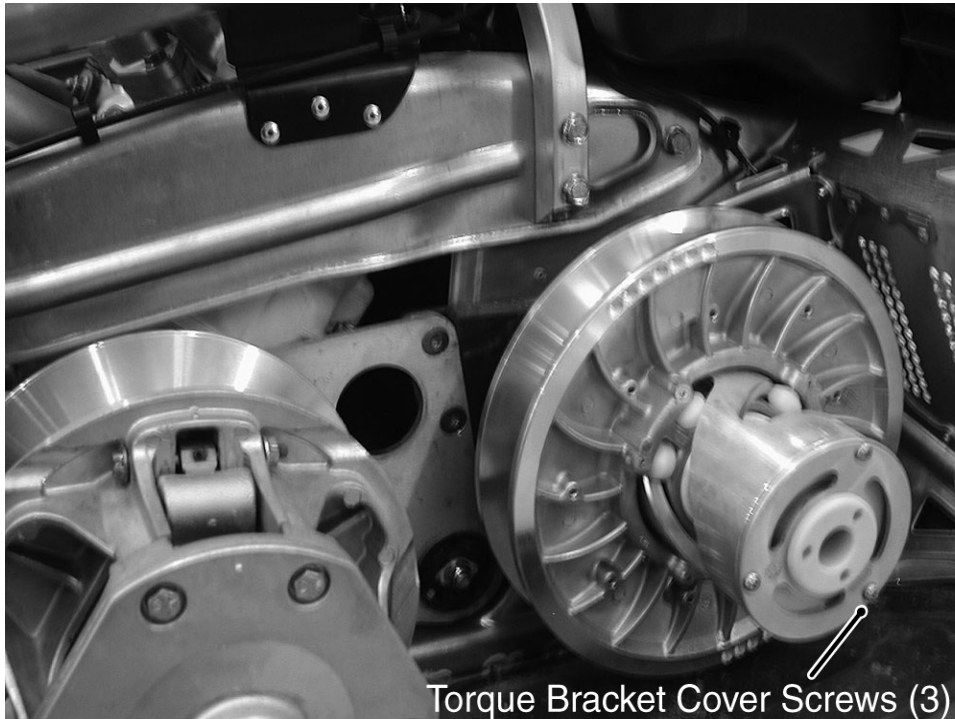
Fig. 1

The three torx-head screws securing the torque bracket cover may not have been properly tightened and may come loose. Remove each screw (one at a time); then add **blue Loctite #243**, install the screw, and tighten to 33-37 in.-lb. Repeat for remaining screws. See Fig. 1.
