SERVICE

8
		B0000019

SB, 240R, 245R, 250R, Throttle handle, 2000-08

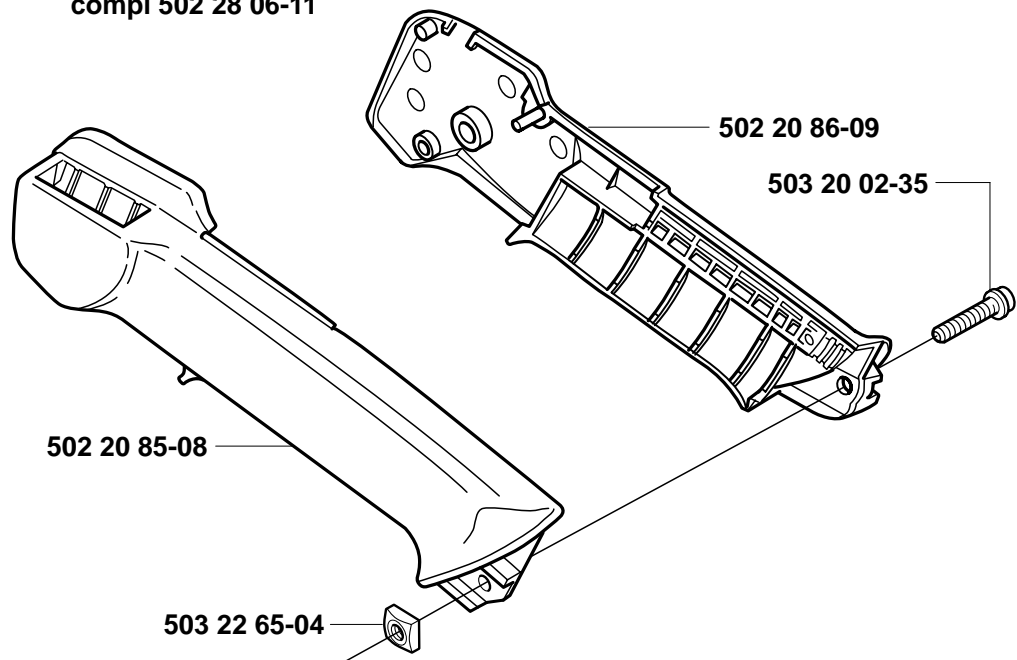
compl 502 28 06-11

The rear fixing screw for the throttle handle, which passes through the handlebar and was previously self-tapping, has now been replaced with a full-length bolt and nut. Both halves of the handle have a recess for the nut, so the bolt can be inserted from either side.

As a result of this change both halves of the handle must be replaced at the same time on older machines. The bolt and nut are also required.

New ref. no.	Description	Excl ref. no.	Remarks
502 28 06-11	Throttle handle assy.	502 28 06-01	
502 20 85-08	Half handle, left	502 20 85-01	
502 20 86-09	Half handle, right	502 20 86-01	
503 20 02-35	Bolt		
503 22 65-04	Nut
