8
		B0100018

SB, 252 RX, 250 R, Throttle cable-cable guard, 2001-03

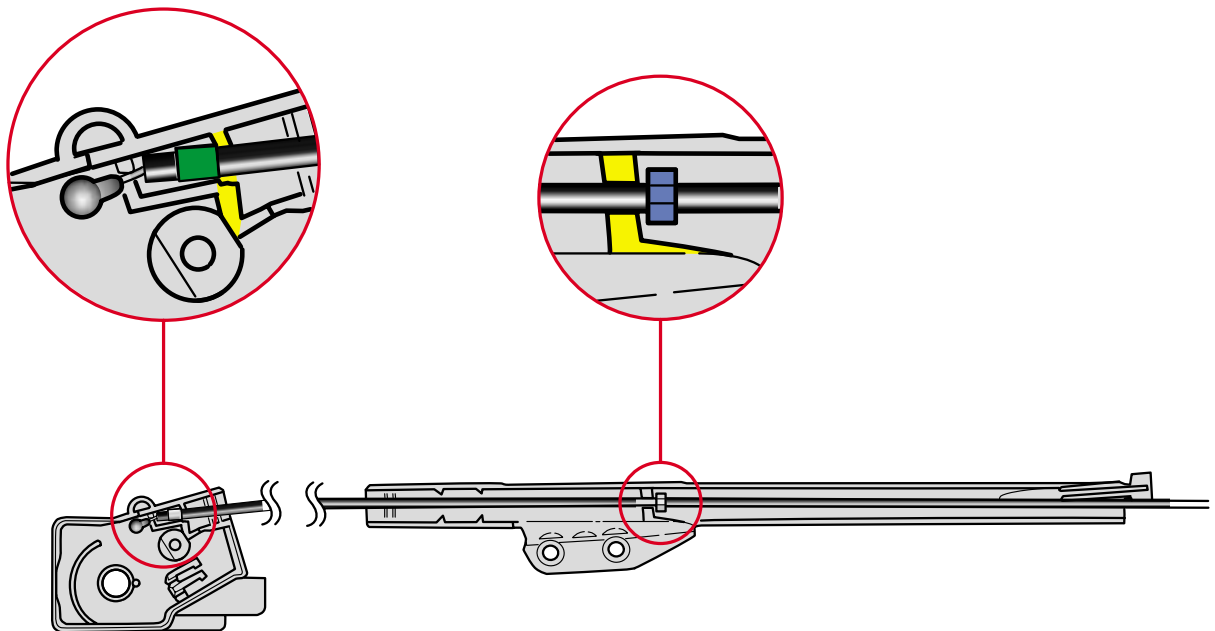
The cable conduit has now been fitted with two stop sleeves on 252RX and one stop sleeve on 250R to prevent unintentional. On both models one stop sleeve is positioned on the conduit and is supported by a wall inside the cable guard. See figure.

252RX also has a stop sleeve on the other end of the cable conduit and which is supported by an existing wall on the throttle handle. See figure. This locks the preventing it from being pulled out of position.

Both cables with stop sleeves and the cable guard with wall must be fitted to give satisfactory protection against unintentional throttle action.

The new parts can also be fitted on older machines.
