**Service
Bulletin**

**B0303011
2003-07**

Subject: Primary Drive Idler Arm & Pulley on the BAM Mower.

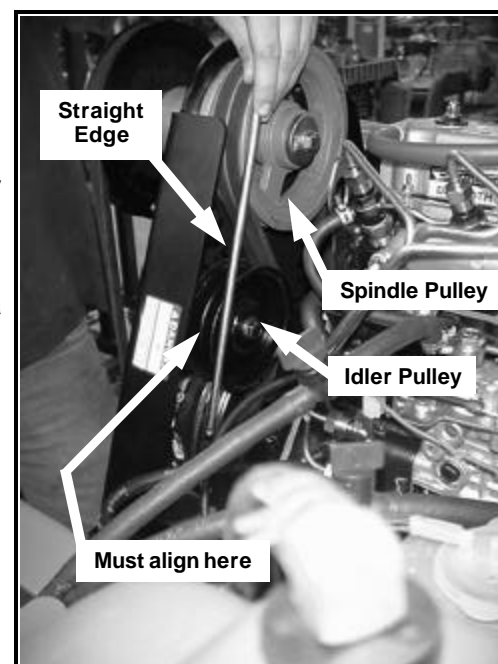
Engine Viewed from the Right Side

There is a possibility that the primary drive belt idler arm may be out of tolerance, allowing the idler pulley to misalign, causing the primary drive belts to prematurely wear or fray.

This can be checked visually, or it can be checked by using a straight edge. Lay the straight edge against the cast pulley on the spindle assembly above the idler. The belts must be centered in the idler pulley, and the idler pulley must in line with the cast spindle pulley.

If the idler pulley is not in alignment as described above, the idler arm is distorted and must be replaced.

The only component that should need to be replaced is the idler arm itself. All other components are transferable. Order part number . . . P/N 539 106422 . . . Idler Arm.
