<b>1</b>
		X 85.100-96

MODEL }  
MODÈLE } **238**

### REPAIR KIT (SUPPORT – CLUTCH COVER)

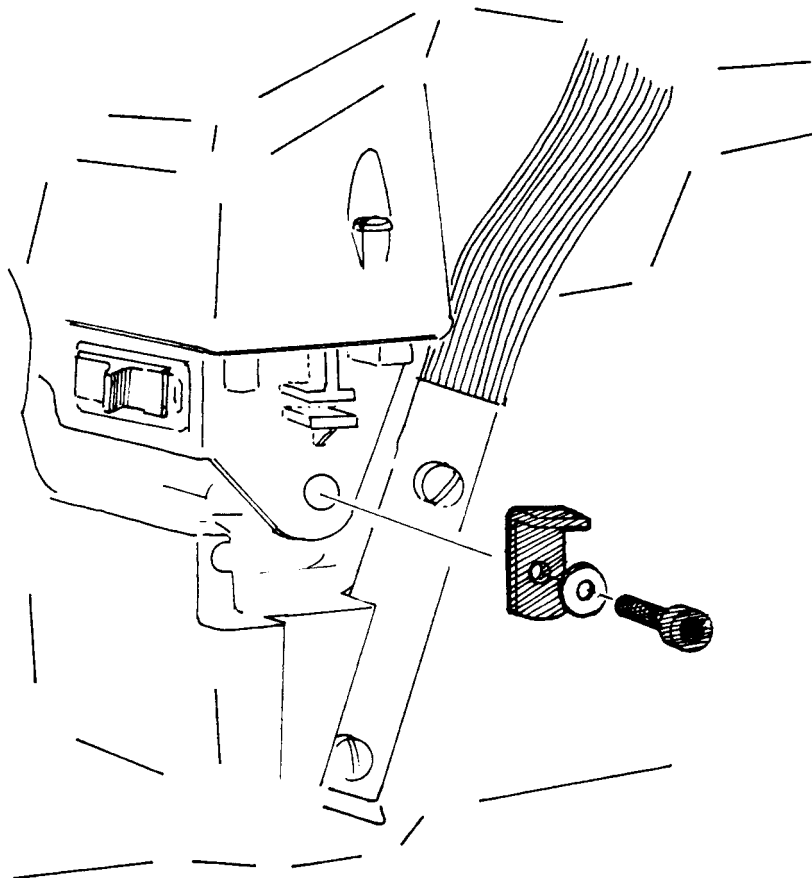
The support post, on the crankcase, for the chainbrake (clutch cover), sometimes shows heavy wear,

Therefore, we have made a repair kit available.

The kit contains:     1 support angle  
                          1 screw  
                          1 washer

Reference number: 503 16 18-01

When assembling the repair kit, file off the bottom portion of the post. Then assemble the kit in the right position over the AV-element.
