SERVICE

7
		X 89.016-26

RIDER 850=8/12

REPAIR KIT FOR STEERING SPINDLE REF. NO. 506 87 68-01

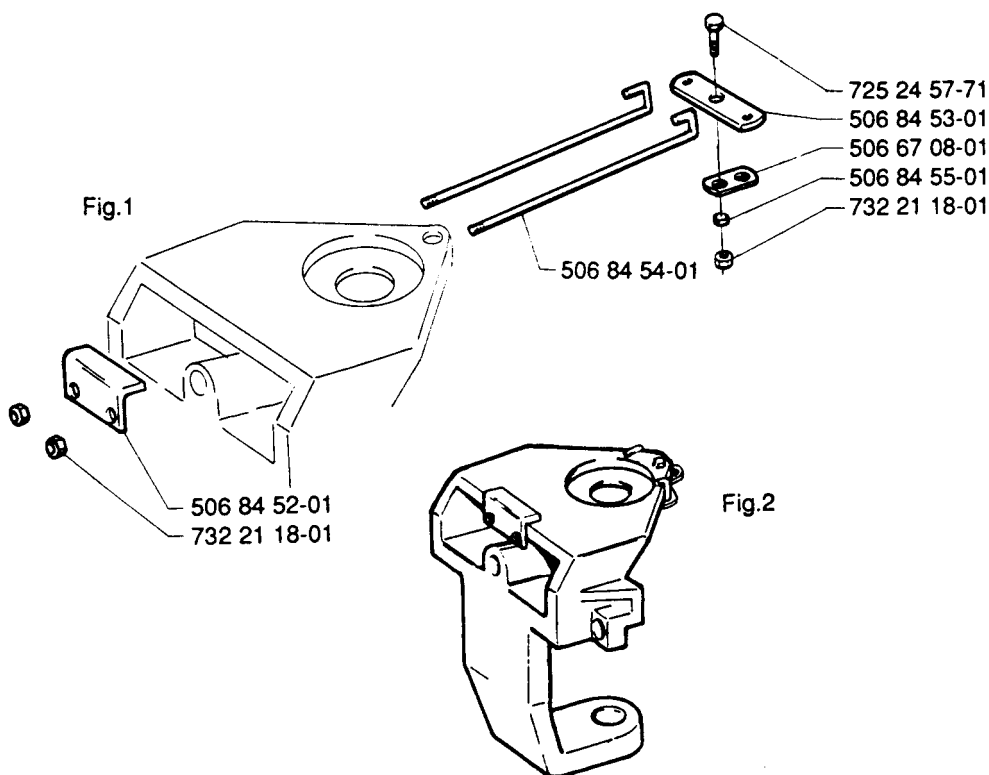
Included parts are shown in ill. 1.

The repair kit is mounted without removing any other parts on the machine. The plate (Ref. No. 506 84 53-01) replaces the worn out hole in the steering spindle. Thread the draw bars through the outer hole in the plate. Place the draw bars under the upper plane on the steering spindle, facing backwards. Mount the bracket (Ref. No. 506 84 52-01) on the draw bars against the back on the steering spindle. Tighten the nuts on the draw bars. Mount the screw (Ref. No. 725 24 57-71), link (Ref. No. 506 67 08-01) and bushing (Ref. No. 506 84 55-01) in the central hole on the plate (Ref. No. 506 84 53-01). The bushing should be mounted in the hole in the link. Tighten up the nut hard, (Ref. No. 732 21 18-01). See illustration 2, fully assembled repair kit. Mount the steering return spring.

On some Rider 850 with casted steering spindle, the screw (Ref. No. 725 24 53-51), which holds the steering return spring, has worn out the hole in the steering spindle. The screw finally comes loose from the steering spindle. In order to avoid changing the whole steering spindle, which requires approx. 8 hours work, we have introduced a repair kit.
