10
		X 91.140-26

MODEL 165 RX

DRIVE SHAFT

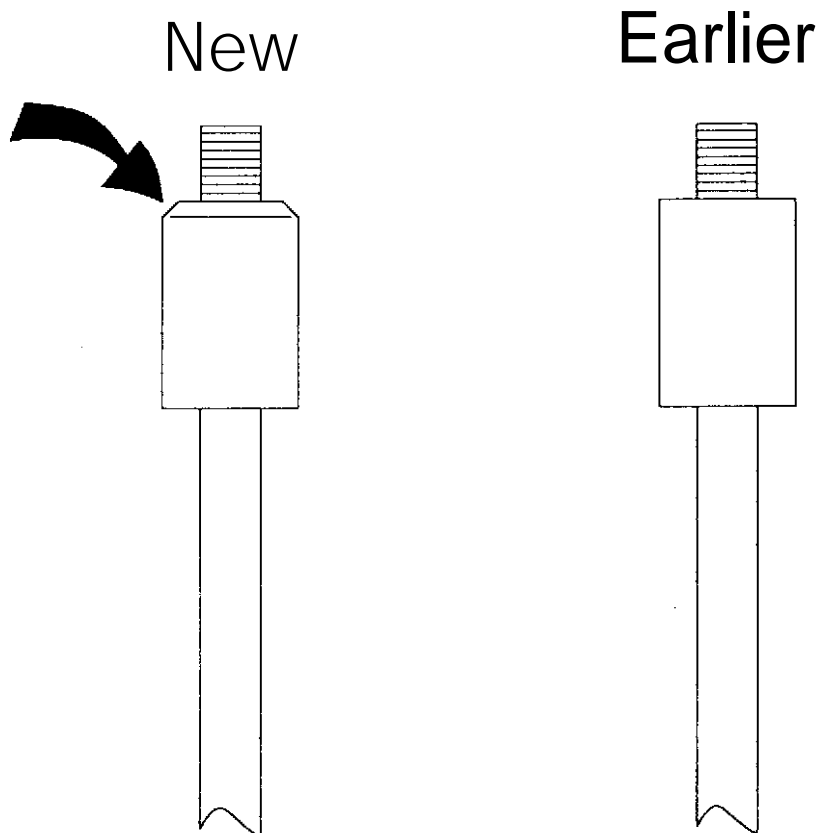
In order to further strengthen the joint between the drive shaft and the clutch drum a new stop sleeve has been added to the drive shaft.

The new stop sleeve is pressed on the drive shaft with a tight fit and therefore counteract any movement in the joint.

The new drive shaft can be recognized by the bevel on the stop sleeve.

The Ref. no. for the complete drive shaft, remains the same: 502 25 78-01.

Introduced from serial no. 1090001.
