Rider 970

We have on some machines noticed breakage on the lifting cable 506 87 03-01.

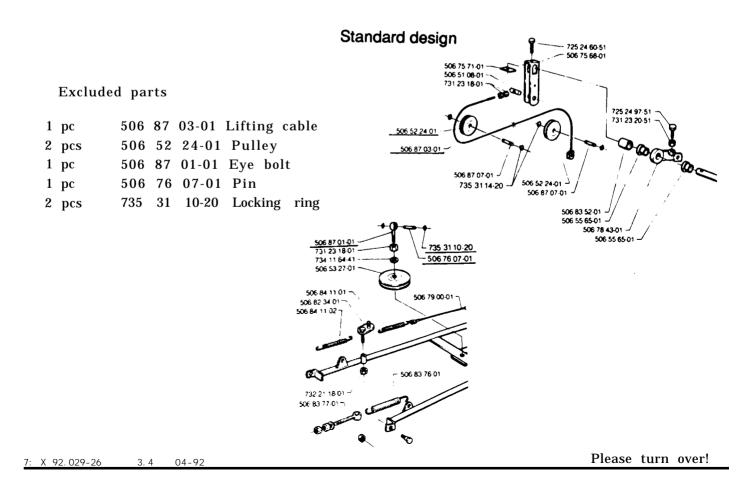
This is due to that cable wears on the plate to the chassis at the inlet above the attachment in the tool frame. This occurs when mowing with a slack cable.

In order to remedy this problem we have introduced a roller chain which replaces the cable.

When mounting the chain, new pulleys and new eye bolts are required.

On machines with frequent problems with the lifting cable, it is advisable to change to this chain.

There is no kit-number for the new parts. They have to be ordered by each ref. no.

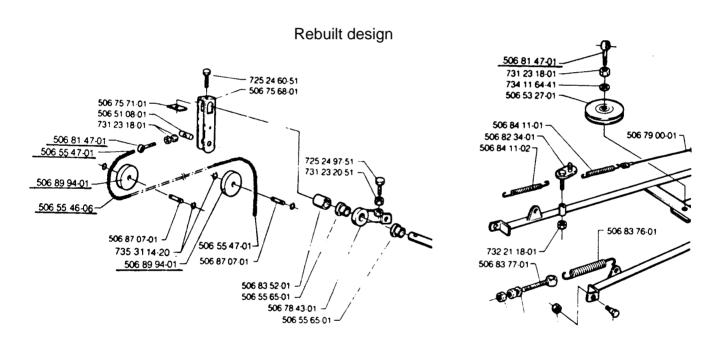
New parts

1	pc	506	55	46-06	Roller chain
2	pcs	506	89	94-01	Pulley
2	pcs	506	81	47-01	Eye bolt
2	pcs	506	55	47-01	Chain lock
