10 X 94.157-26
--	--	--------------------------

Model 225/232

Gear housing

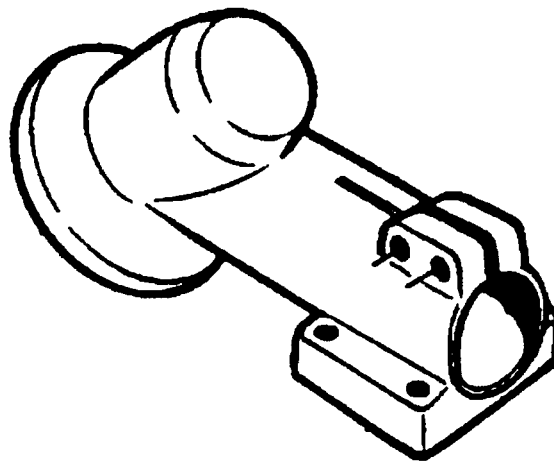
The clamping joint on the gear housing has been fitted with two screws instead of one. The clamping force is now distributed more evenly along the shaft. At the same time the edge of the gear housing that joins the shaft has been bevelled.

Introduced into production from week 38.
