<b>8</b>
		97-06-18

## Model 250R/RX

### Throttle cable

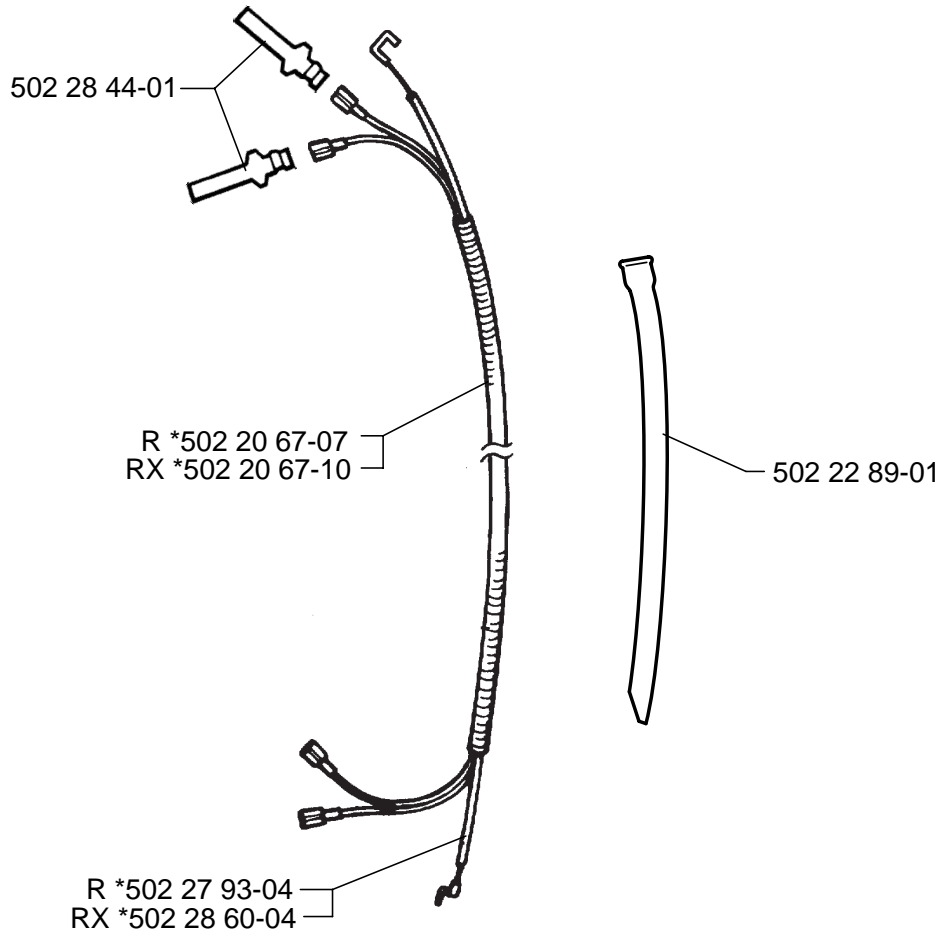
The routing of the throttle cable between the throttle handle and the carburettor has been modified to make the cable run more freely. Originally the cable ran from the fuel tank straight to the left and then straight back. This sometimes led to cable seizing.

The cable now runs from the right side of the tank, straight backwards, through the crankcase at an angle and then up to the carburettor. The cable now makes a long, smooth curve and runs much more easily.

Where the cable passes through the crankcase a plastic hose is fitted to protect the cable from abrasion. Machines that use the earlier cable routing can be converted to the new one. See service bulletin 97-05-16, section 8.

This modification means that the throttle cable is now longer, so it has a new part number. The same applies to the cable assembly. The plastic hose for the crankcase is a new part.

R \*compl 502 27 92-08  
RX \*compl 502 27 92-07
