Service Note	2001-10
	N0101003

Models 322 / 325 Series Equipment

Subject: Improved Starter Pawl & Pawl Housing Assembly

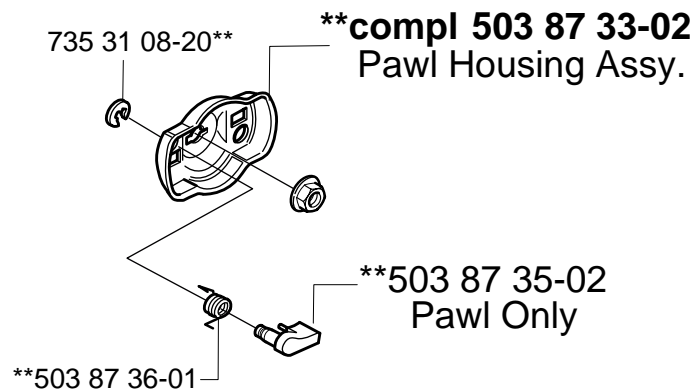
The original pawl was gray in color and was reported to be too brittle. The material was changed when the black pawl was introduced, but some reports indicated that the new material was susceptible to melting. The final version of the pawl is brown (modification letter H) and has shown to be resistant to both breakage and melting.

The pawl housing assembly has also been improved. Starting with serial number 991301009, it is now reinforced with a washer brazed to the bottom of the cup.

If you experience a problem with the starter system on one of these units, please verify the serial number and do the following:

- 1) Prior to serial number 991301009, replace the entire pawl housing assembly (503 87 33-02).
- 2) After serial number 991301009, replace the pawls only (503 87 35-02).
