SB, Rider ProFlex 18, Rider Pro 18, Bolt, 2003-05

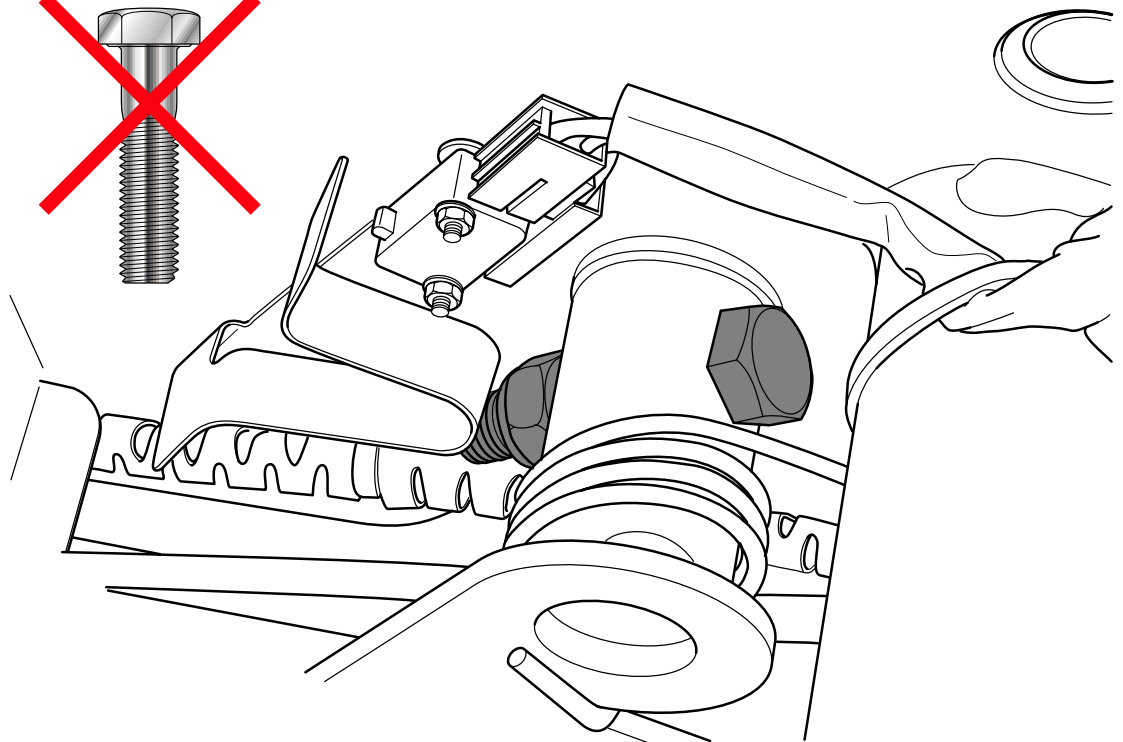
It has been discovered that, during week 10, the bolt that was fitted to activate the microswitch for the cutting deck is 10 mm too short.

The problem that arises is that the Rider cannot be started when the cutting deck is fitted to the machine.

725 25 44-51

~~725 25 42-51~~

The fault can be rectified by replacing this bolt.

The correct bolt can be ordered direct from stock: part no. 725 25 44-51.
