| <b>SERVICE</b><br> | | <b>8</b><br>X 88.110-96 |

MODELS } **238/242/254/266/268/281**  
 MODÈLE }

### HANDLE HEATING

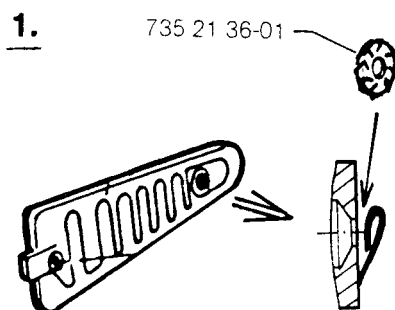
Functional disorder which are caused by a poor contact between the resistance wire in the handle insert and the sleeve can be repaired according to the below:

1. Place the locking washer between the wire and the handle insert. This should be done on both handle inserts.
2. Shorten the sleeve approx. 1,5 mm (0.05") in order to compensate for the two washers.
3. Mount the two handle inserts.

1. Placer la rondelle entre le fil et l' insert. NOTA: Dans les deux poignées.
2. Raccourcir la douille d' environ 1,5 mm, pour compenser les deux rondelles.
3. Monter les deux inserts.
