SERVICE

8
		X 89.118-26

MODELS 40,45

THROTTLE CATCH

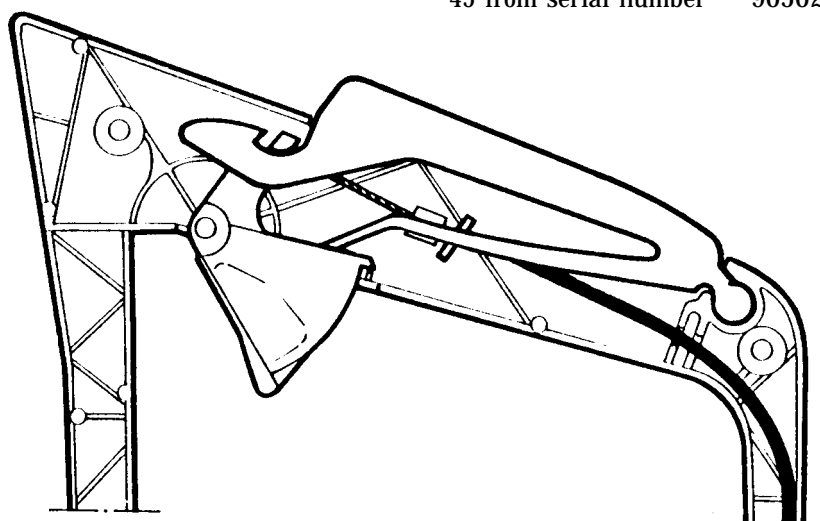
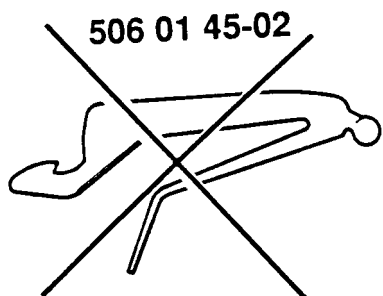
In order to improve the throttle cable housing attachment in the rear handle, a stop cleat is introduced on the throttle trigger lockout.

New Ref. No.	Description	Excluded Ref. No
506 01 45-04	Throttle trigger lockout	506 01 45-02
The change is introduced on the model:		
	40 from serial number	9050401
	45 from serial number	9050297
