Model Royal 43 S

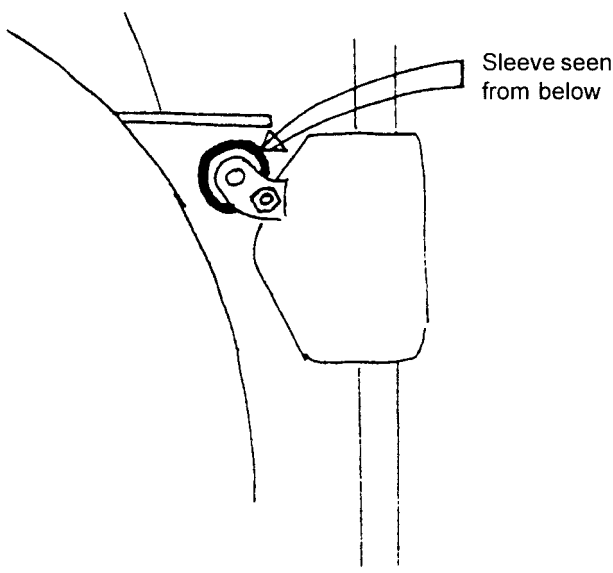
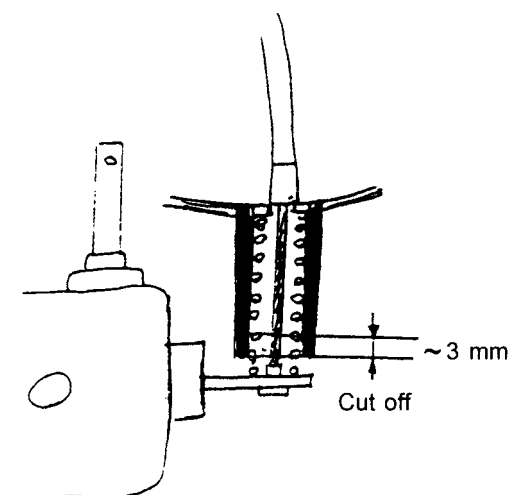
Some of the above named lawn mowers can lose their drive capacity due to the belt slipping. If this cannot be adjusted using the wire it can be due to adverse belt tolerances or the cutting deck. One way to increase the tensioning possibilities of the belt is to remove material from the sleeve around the gearbox's tensioning spring.

- Empty the oil and fuel.
- Remove the belt and belt pulley.
- Loosen the wire from the gearbox and remove the spring.
- Remove the rear wheel suspension (it is best to remove the bearing cover and then fold back the rear wheel suspension to avoid replacing the start lock washer on the height adjustment stay).
- Cut approx. 3 cm off the sleeve (chisel, sharp knife or any other tool can be used).
- Reassemble
