SERVICE

10
		X 94.154-26

Model **225/232**

Clutch cover

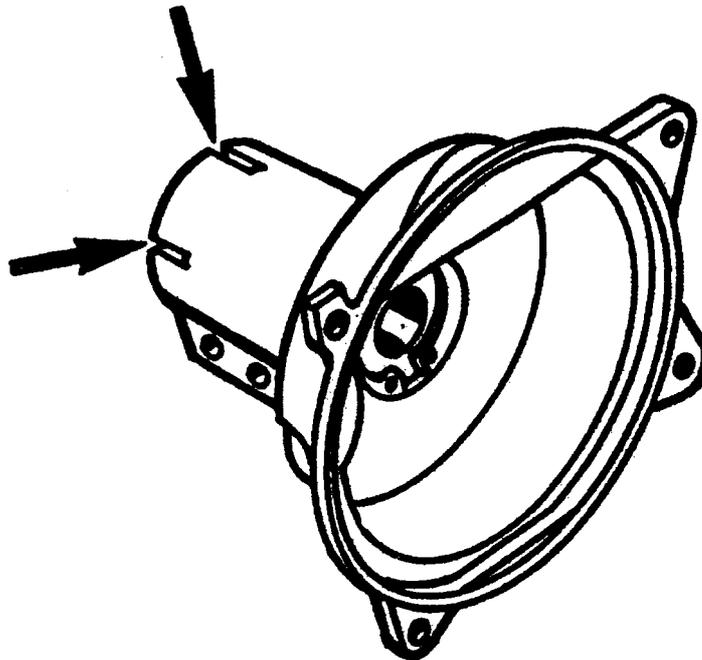
There have been a small number of fractures on shafts by the connection to the clutch cover. To prevent this, the clutch cover has been slotted by the clamping joint to provide a smoother transition between the rigidity of the clutch cover and the shaft.

Introduced into production from week 26.
