Models 232 and 235

Clutch

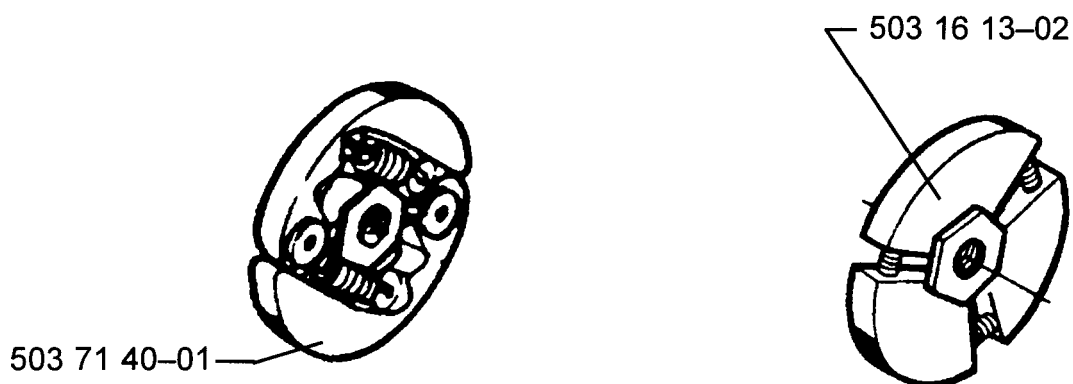
In the new spare parts list for 1994 models 232/235, ref. no. 106 23 72-63, the replacement clutch for both the 232 and 235 is shown as ref. no. 503 71 40-01.

It has turned out that this clutch slips when fitted to the 235. The clutch also slips slightly at working speed. This leads to heat build-up and the risk that the plastic in the crankcase will be damaged. Production models of the 235 will be fitted with the old clutch, ref. no. 503 16 13-02 during 1994. The problem described above does not affect the 232, and the new clutch, ref. no. 503 71 40-01 will continue to be fitted to this machine in production.

We have therefore decided that the old clutch, ref. no. 503 16 13-02, will be used as a replacement clutch for the 235.

The new clutch, ref. no. 503 71 40-01, will still be used as a replacement clutch for the model 232.
