Service
Note

N0101001

Affected: 225 HBV / 225 HBV Lite

Subject: Spacer Orientation During Reassembly

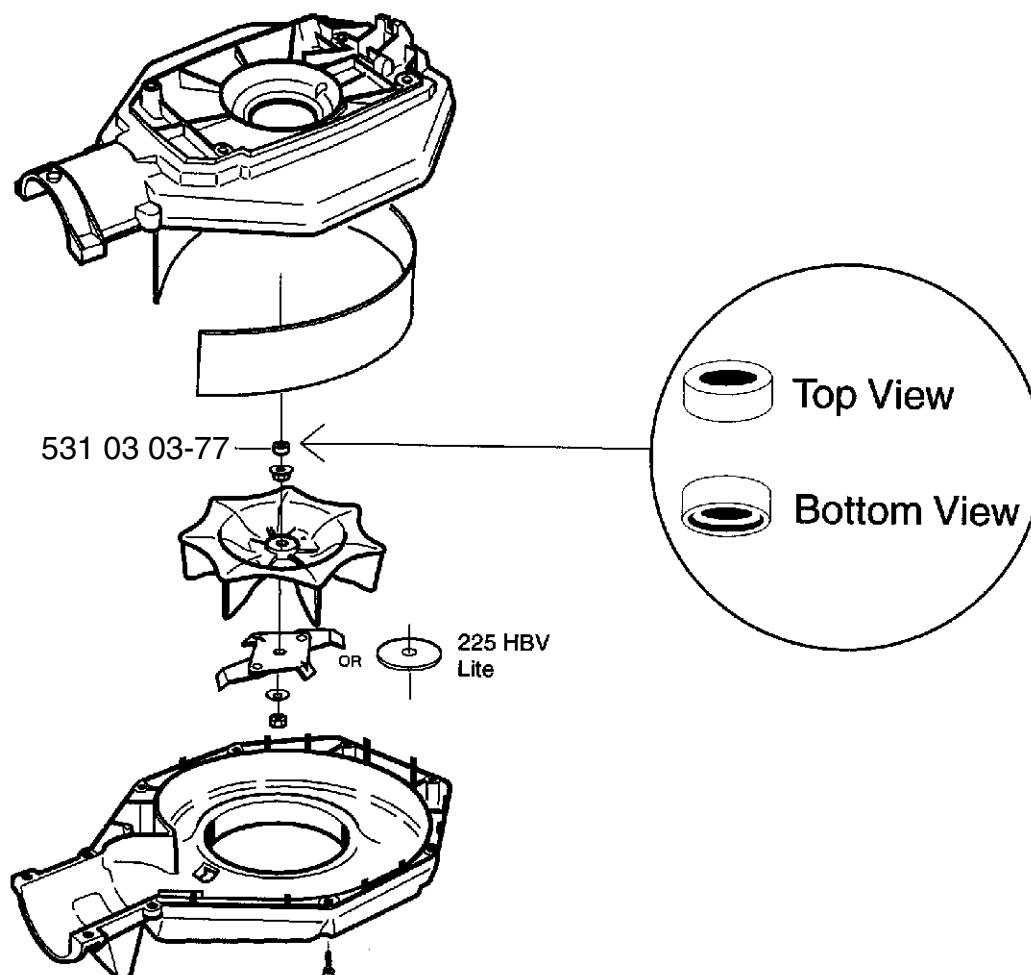
The subject blowers use a spacer (part # 531 03 03-77) that is machined on one side and flat on the other. This causes some confusion when reassembling the unit after repairs are made.

Please review the attached diagram showing how the spacer should be oriented during reassembly. The spacer should be installed with the flat side toward the engine assembly and the machined side toward the fan.
