## MODEL: LTH and YTH Riding Mowers with Cast Iron Axles

### SUBJECT: Excessive Front Axle Movement.

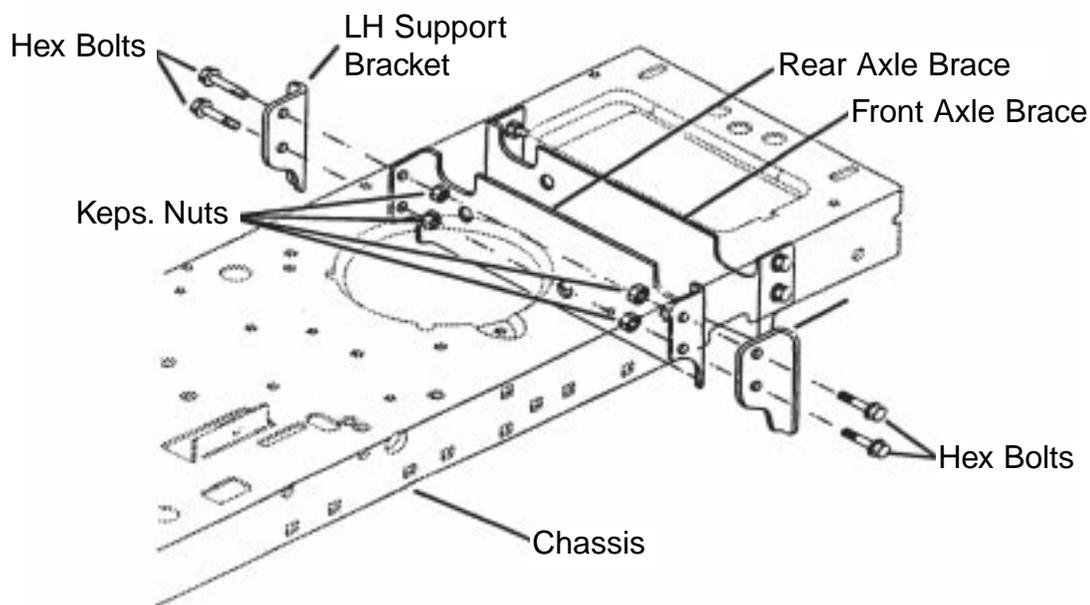
Some of the 1998 production mowers listed above had an oversized bushing install in the cast iron axle which increased the axle saddle width at each end. This can allow the axle to move back and forth. It can be corrected with the kit listed below. This will also work on any prior 1998 models listed above with the same symptoms.

Complete RH bracket installation before starting LH side.

- 1) Remove and discard (2) bolts connecting rear axle brace on right side of chassis.
- 2) Install support bracket with (2) bolts and (2) nuts supplied as shown. Tighten securely.
- 3) Repeat procedure on left side of chassis.
