2012 ATV and ROV Updates

2012 ATV and Prowler Update

HDX Transmission Improvements

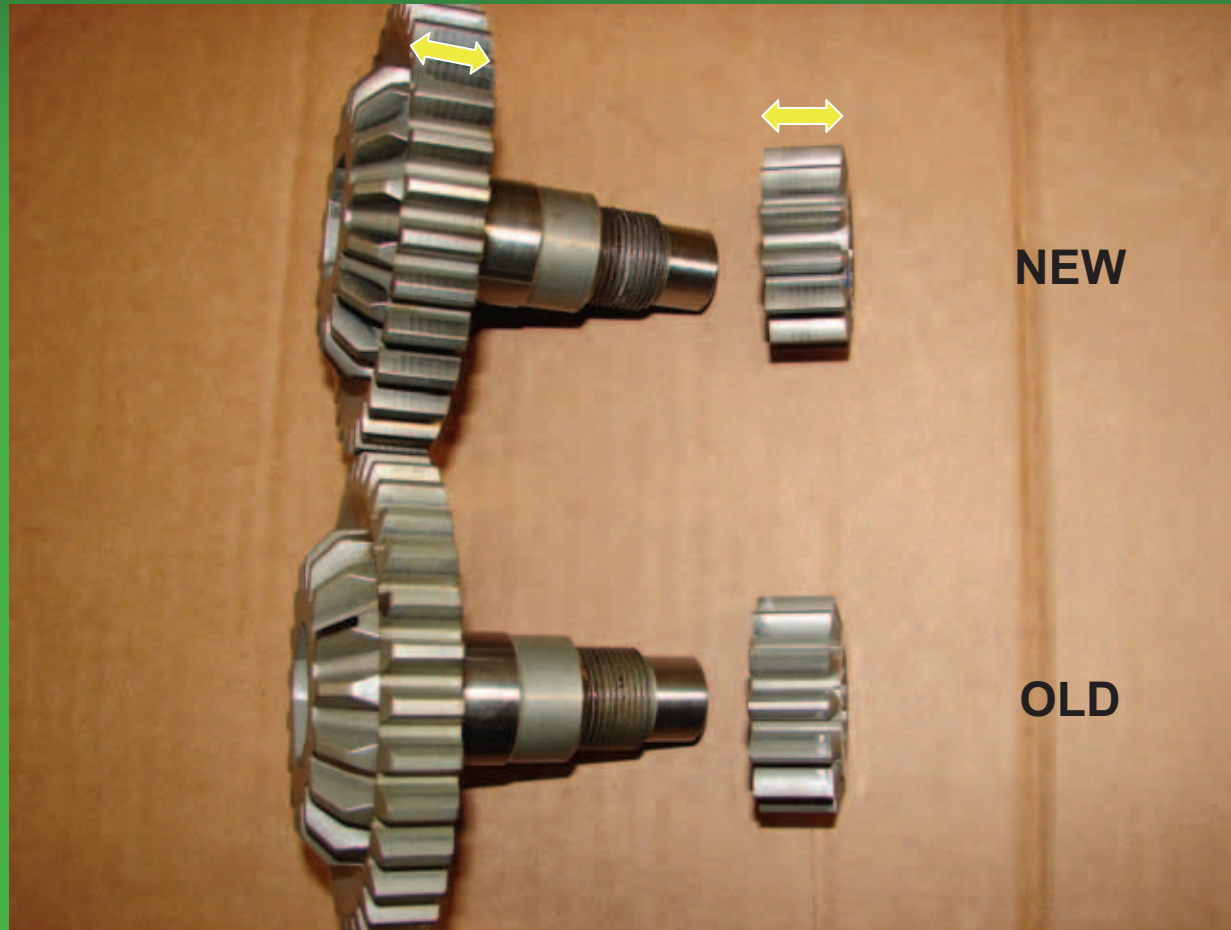
Secondary Drive Gear

Wider gears on the secondary drive.

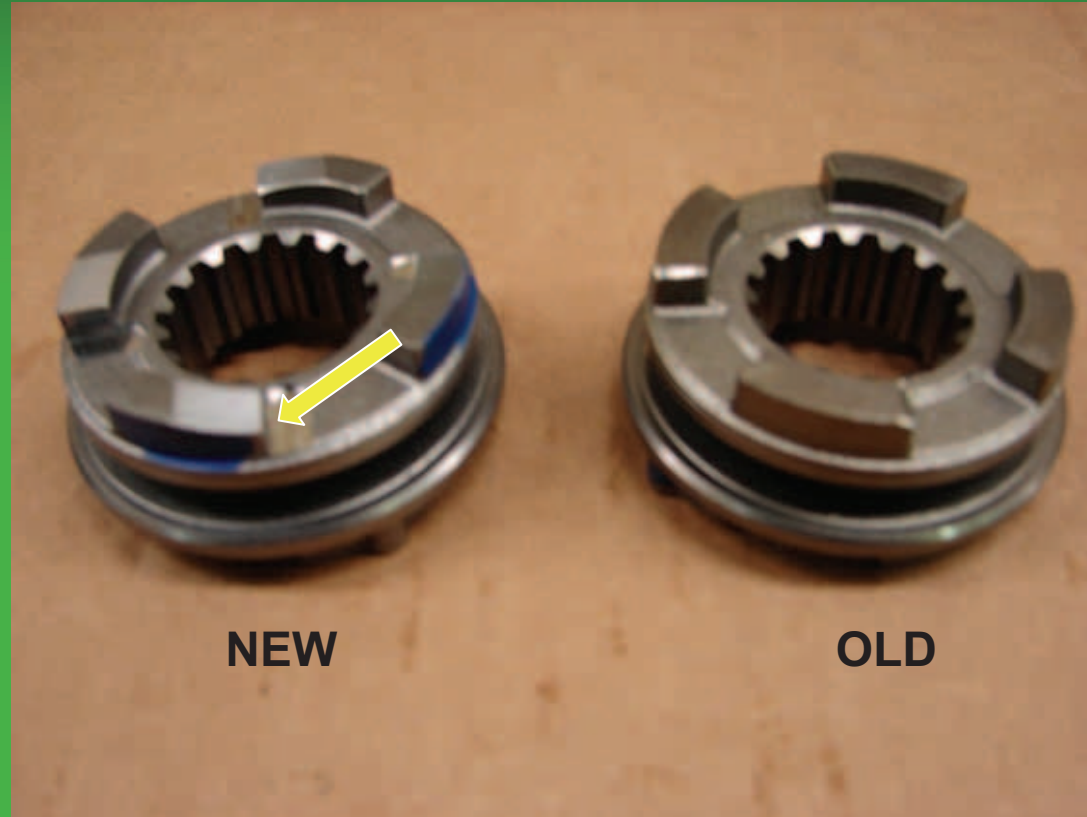
Sliding High Range / Reverse Gear Selector

The gear selector has an undercut of 89.5° to accommodate the modified area on the high range gear.

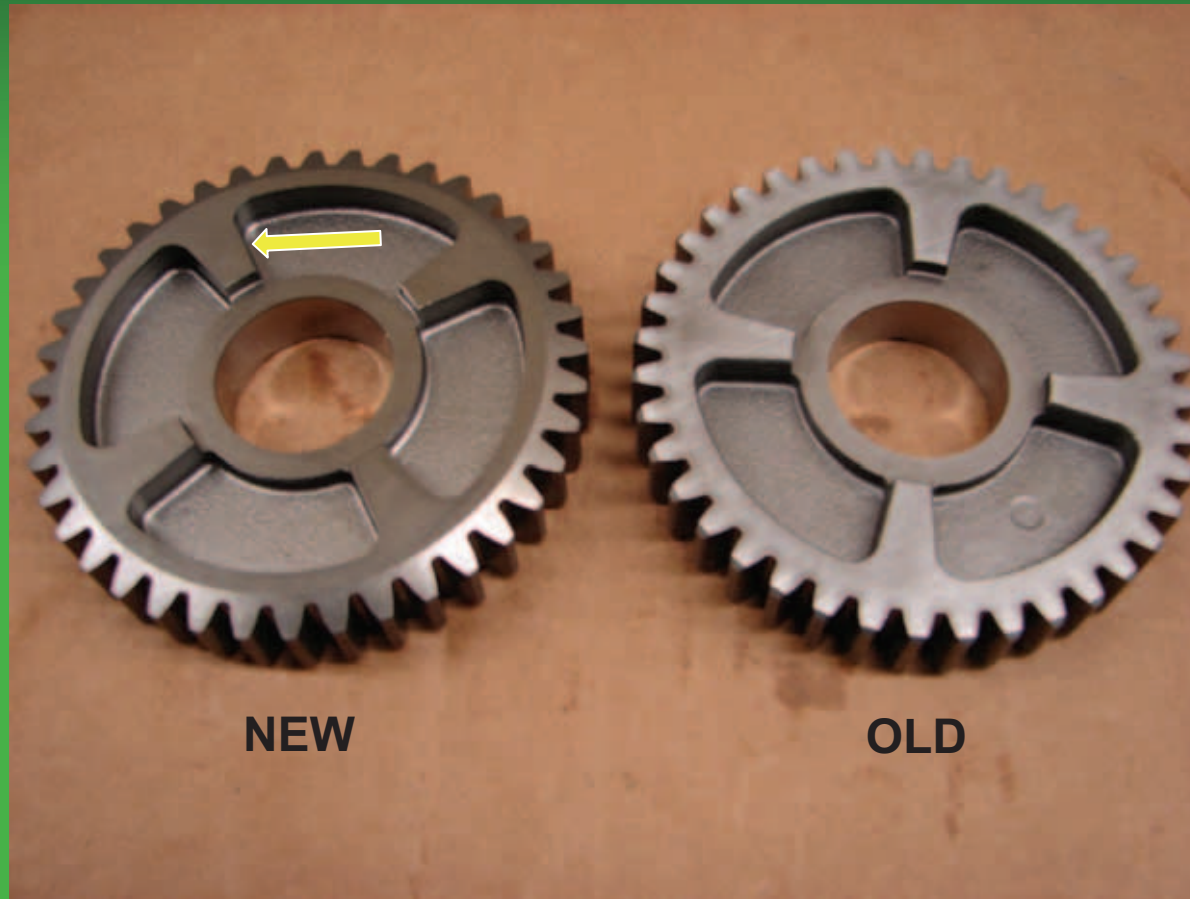
Driven Low Range Gear

**Low range gear now has a forged chamfer,
this will help against breaking.**

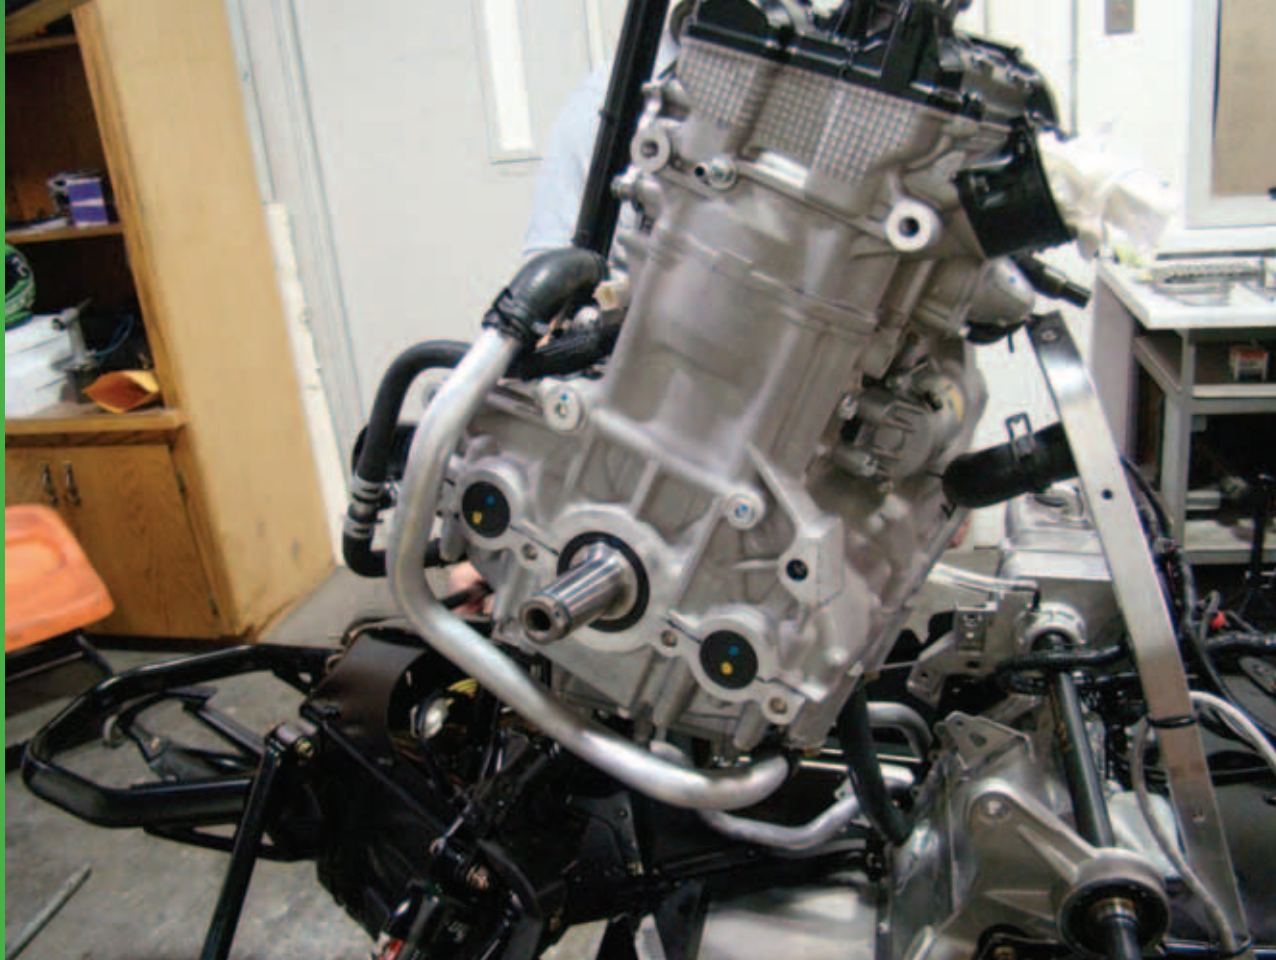
Check the inner side of the bearing to be sure the seal is still in place.

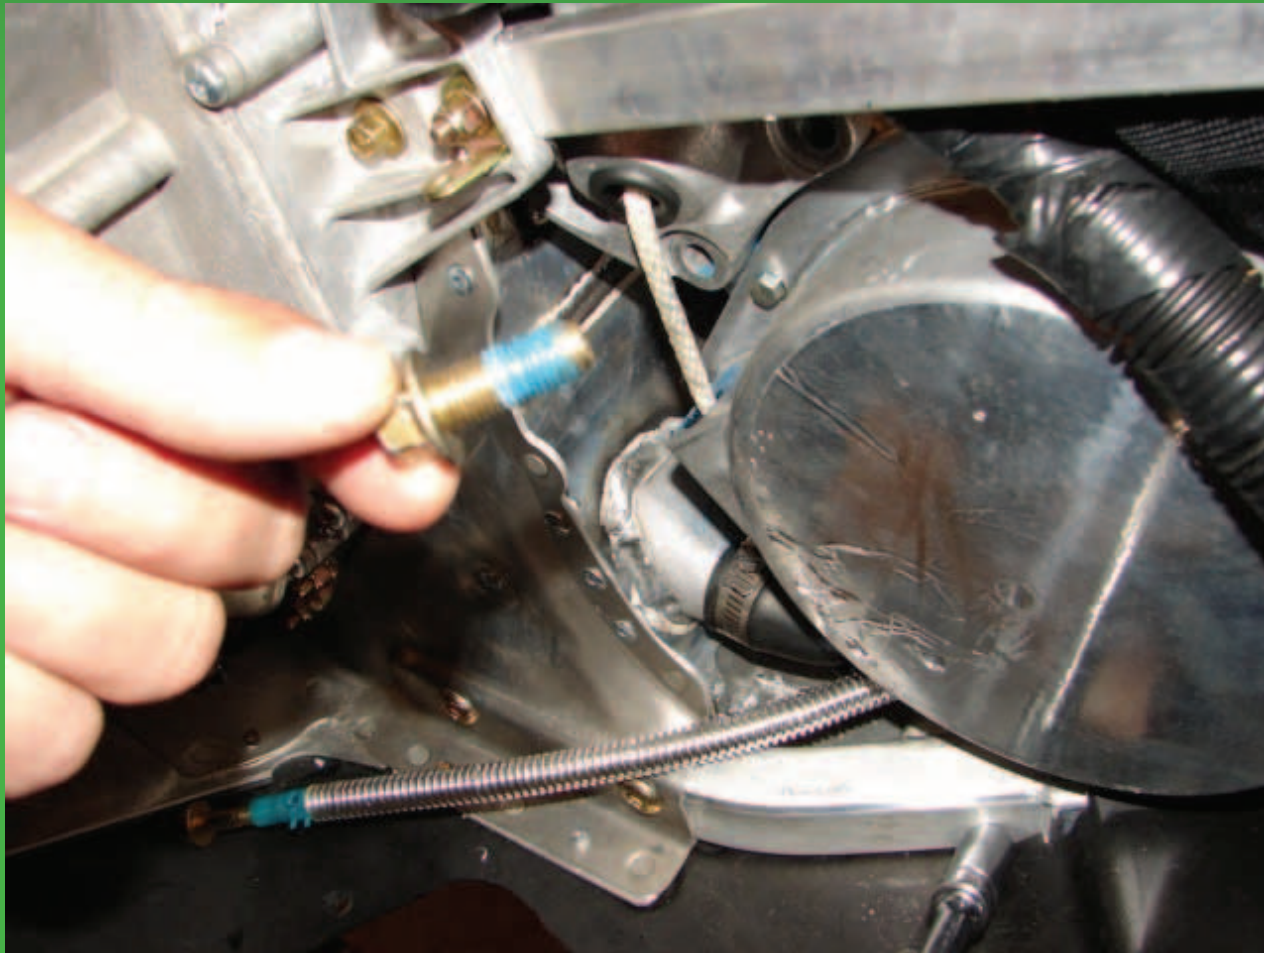
Loctite™ 242 Blue was applied to all fasteners and
torqued to specification.
